AEFA Project No. 87-25-1

# EVALUATION OF THE IMPROVED OV-1D ANTI-ICING SYSTEM PHASE II

April 1989

Final Report

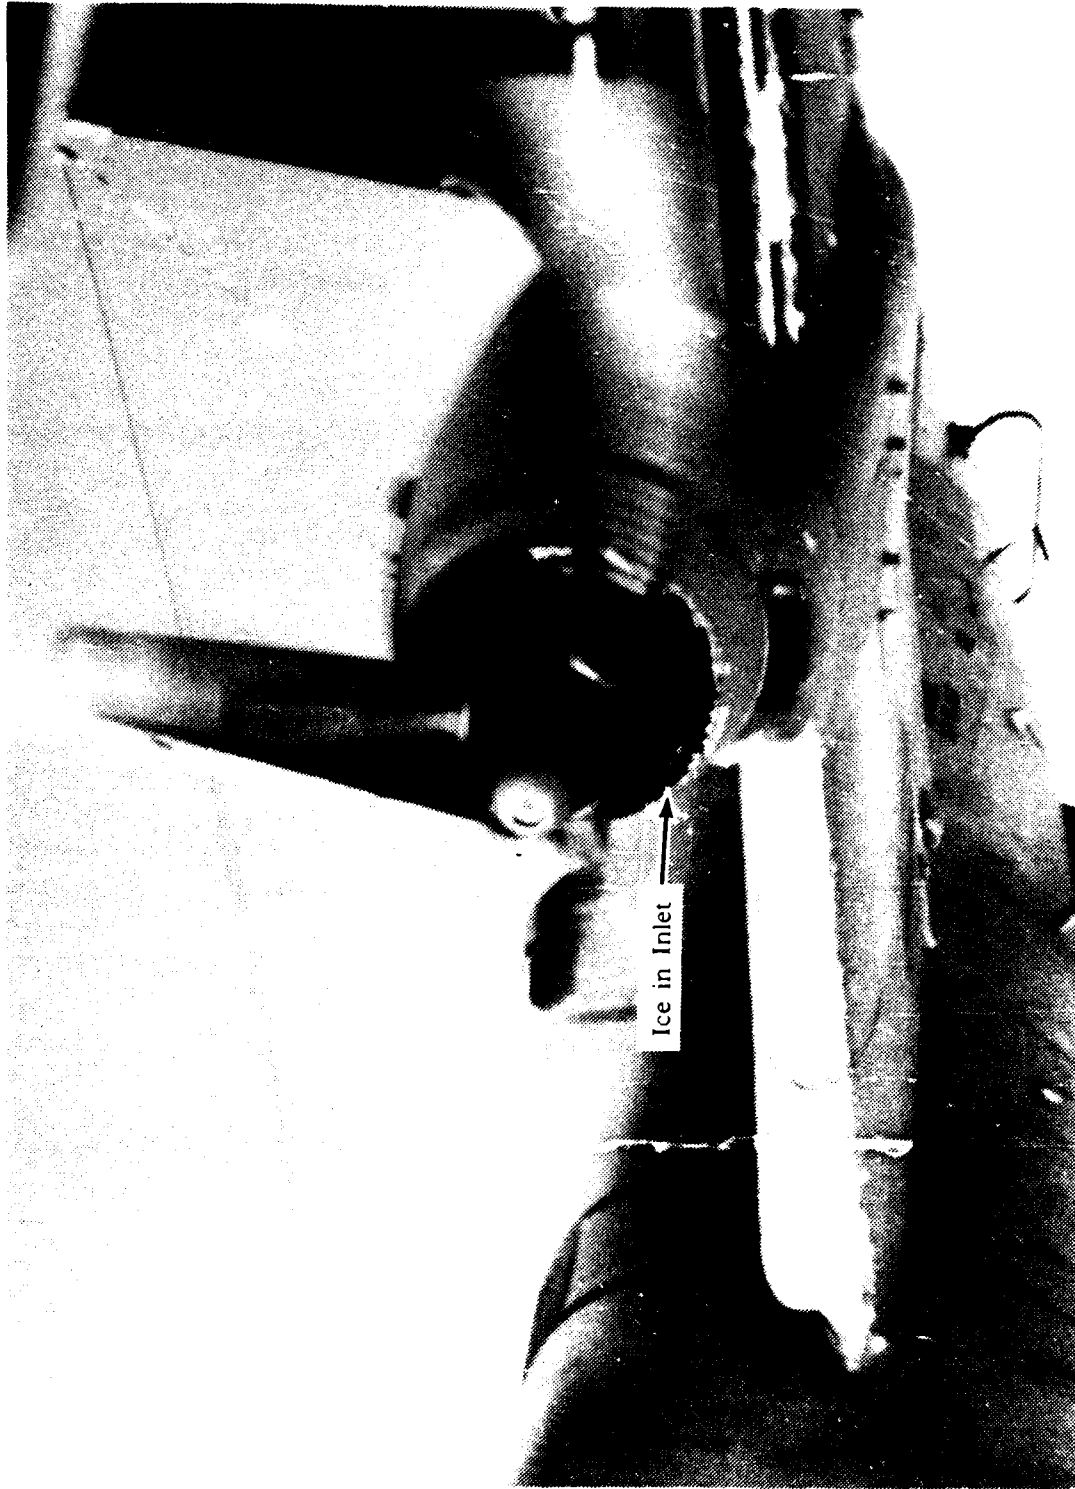
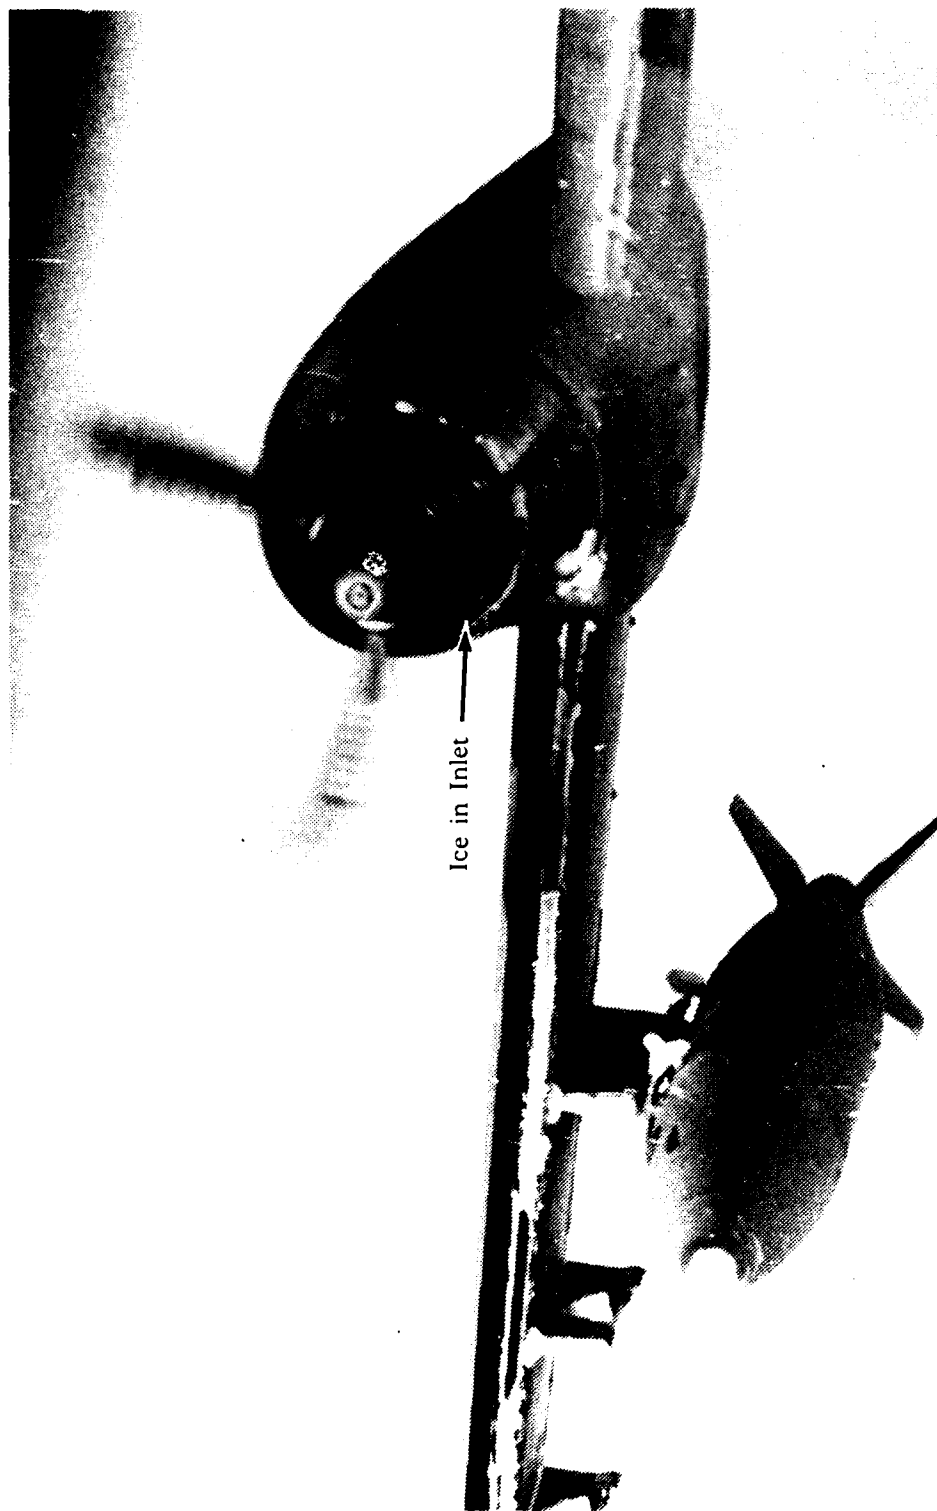
7. The ice accretion characteristics of the engine inlet at temperatures colder than -15 degrees C were reported as a deficiency during AEFA Project No. 87-25. The actual temperature at which ice starts to accrete in the inlet was determined during this test to be -11 degrees C (figs. D-1 and D-2). The failure of the anti-icing system to keep the engine inlet clear at temperatures colder than -10 degrees C is a deficiency. The engine inlet anti-ice system should be redesigned to allow safe operation in icing conditions at temperatures colder than -10 degrees C. The OV-1 with the improved anti-icing system should be cleared into icing conditions up to and including moderate with ambient temperatures no colder than -10°C.

\*b. The failure of the anti-icing system to keep the engine inlet clear at temperatures colder than -10 degrees C (para 7).

Figure D-1. Ice in Inlet: LWC = 0.6 gm/m<sup>3</sup>, Time in Cloud = 0.5 hr, OAT = -11°C

Figure D-2. Ice in Inlet: LWC =  $0.6 \text{ gm/m}^3$ , Time in Cloud = 0.5 hr, OAT =  $-11^\circ\text{C}$

29. Correct the deficiencies listed in paragraphs 27a through 27c prior to release of the aircraft for flight in icing conditions at temperature colder than -10°C.
30. Correct the deficiencies listed in paragraphs 27d and 27e prior to release of the aircraft for flight in icing conditions at any temperature.
31. Correct the deficiencies listed in paragraphs 27f and 27g prior to release of the aircraft for operational mission or for flight in instrument meteorological conditions.
32. Correct the shortcomings listed in paragraph 28 as soon as practicable.
33. The following WARNING should be placed in the operator's manual.

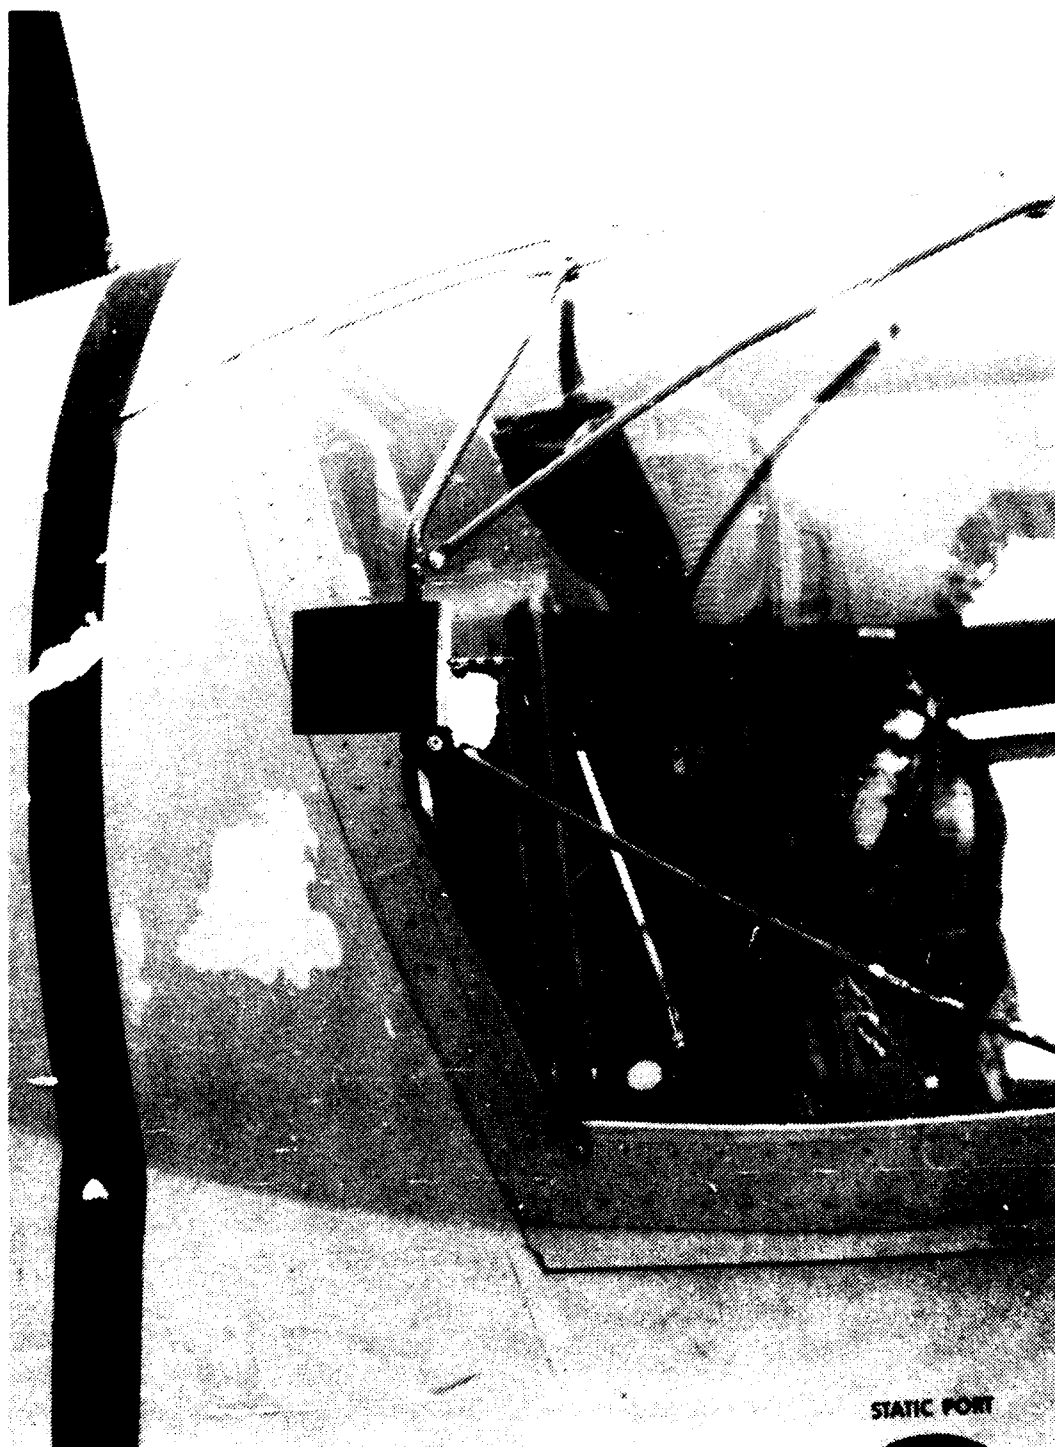
15. Propeller and wing ice sheds occurred during deice cycles in all of the icing conditions tested. Ice departing the blades and or wings frequently hit the fuselage, empennage or fuel drop tanks. Figures D-3, D-4, and D-9 shows fuselage damage resulting from propeller ice sheds. Dents as large as 3/8 inch deep and 4 inches in diameter were observed during AEFA Project 87-25. The propeller shedding characteristics are a shortcoming because of the resulting fuselage, empennage and drop-tank damage.

\*a. The propeller shedding characteristics are a shortcoming because of the resulting fuselage, empennage and drop tank damage (paras 8 and 15).

Figure D-3. Ice Damage from Propeller

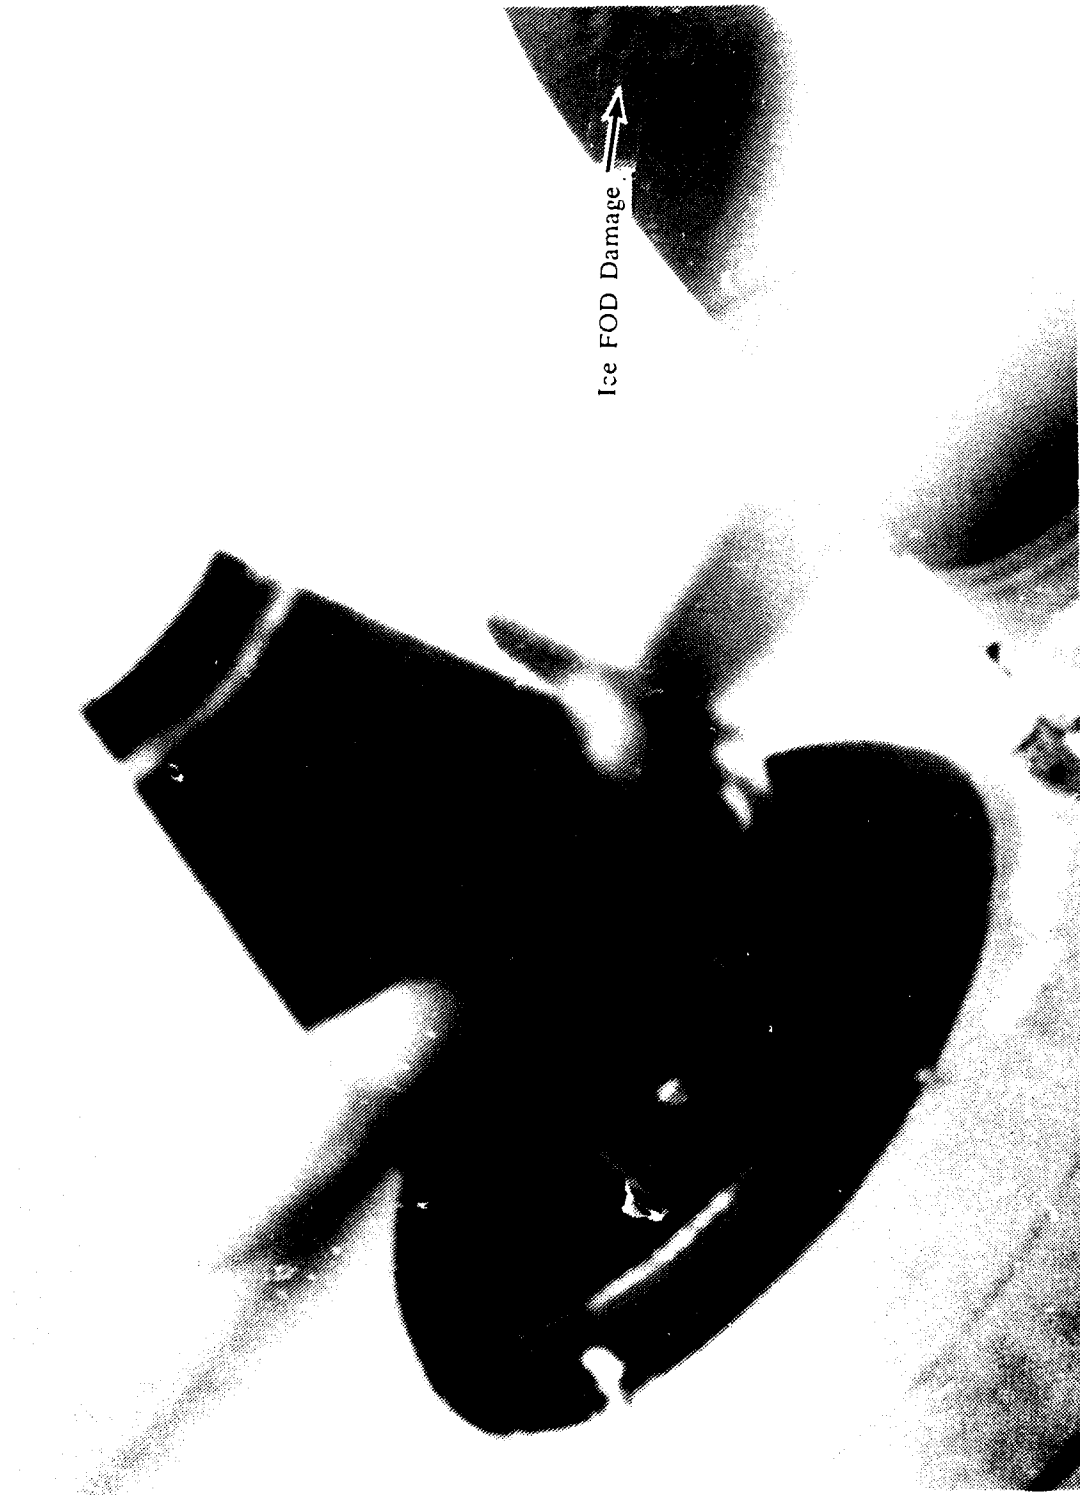
Figure D-4. Ice Damage to Left Drop Tank from Propeller

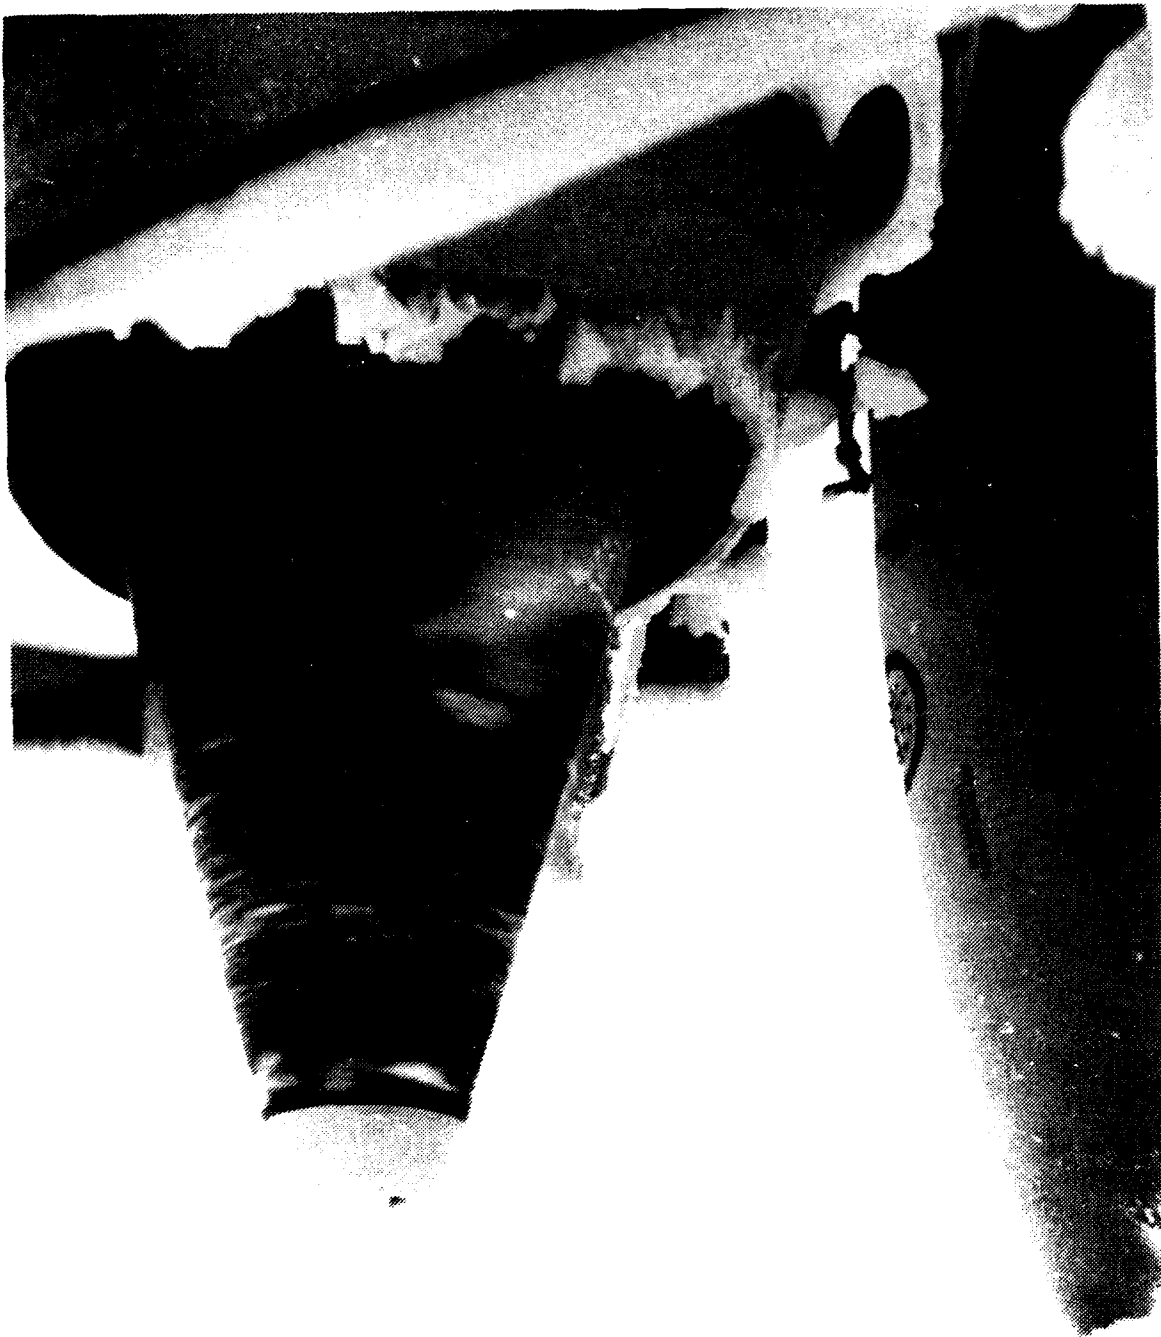
9. The propeller spinner nose was anti-iced at the aluminum cap only (fig. D-5). The spinner accreted ice in a donut or crown shape. Shedding ice was observed to go down through the propeller and away from the engine inlet area. No ice damage was noted on the propeller. As reported in AEFA Project No. 87-25, splinter ice formations started growing on the spinner portion just aft of the "crown" and accumulated to a depth of 1/2 to 1 inch (fig. D-5) in light and moderate icing conditions. Grumman analysis showed that any accretions on the spinner aft of the aluminum cap would be thrown out of the engine inlet area by centrifugal force and, therefore, was not considered to be an ingestion hazard to the engine. No ice from the propeller nose and spinner was observed being ingested by the engine. The ice accretion and shedding characteristics of the propeller nose and spinner are satisfactory.

Figure D-5. Propeller, Nose, Spinner Ice Accretions: LWC = 0.6 gm/m<sup>3</sup>, Time in Cloud = 0.5 hr,  
OAT = -11°C

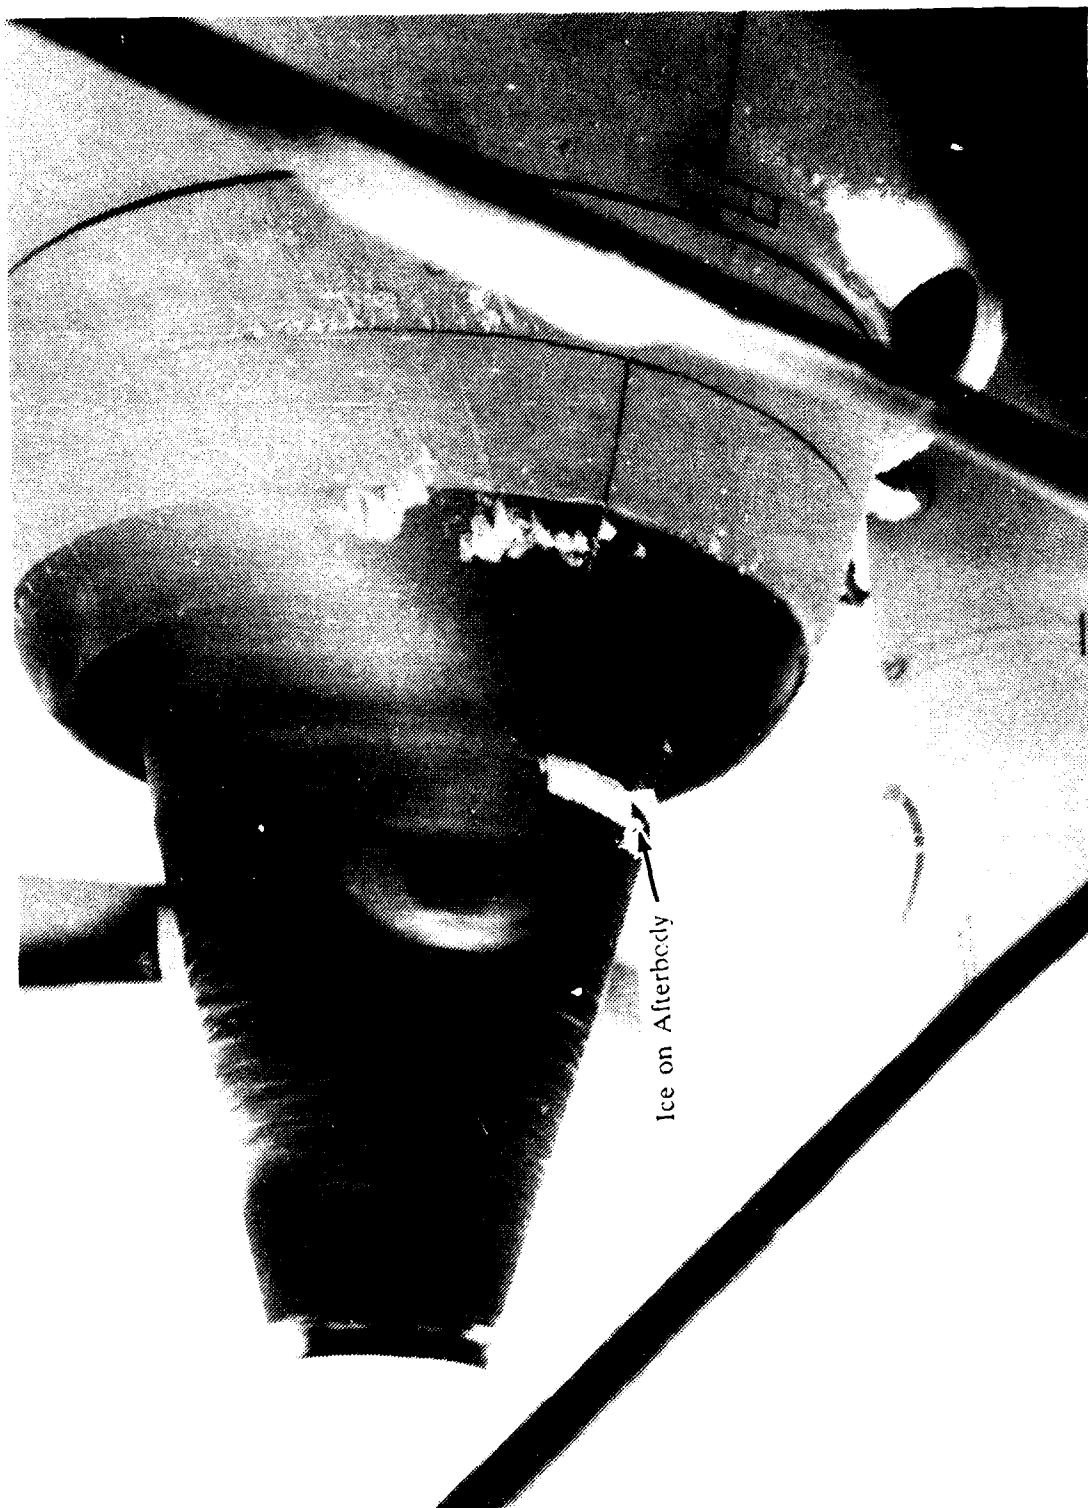
10. Splinter shaped ice accreted on the spinner afterbody on the bottom portion from the 4 to 8 o'clock positions from the leading edge of the afterbody to approximately 6 inches aft (fig. D-6). During icing encounters, ice accreted at the leading edge of the afterbody and grew forward until it was dislodged by vibration or air pressure, or impacted by the rotating propeller blade shank. When a section of the accreted ice broke off, it was ingested into the inlet and, therefore, is a potential ingestion hazard to the engine, although there was no engine damage noted. At temperatures colder than -10 degrees C the splinter shaped ice accretions grew to approximately two inches by three-fourths inch in thickness prior to shedding. The ice accretion and shedding characteristics of the propeller spinner afterbody which may result in ice foreign object damage (FOD) to the engine in light and moderate icing conditions at temperatures colder than -10 degrees C are a deficiency.

\*c. The ice accretion and shedding characteristics of the propeller spinner afterbody which may result in ice FOD to the engine in light and moderate icing conditions at temperatures colder than -10 degrees C (para 10).

Figure D-6. Propeller Spinner Afterbody: LWC = 0.6 gm/m<sup>3</sup>, Time in Cloud = 0.8 hr, OAT = -8.0°C

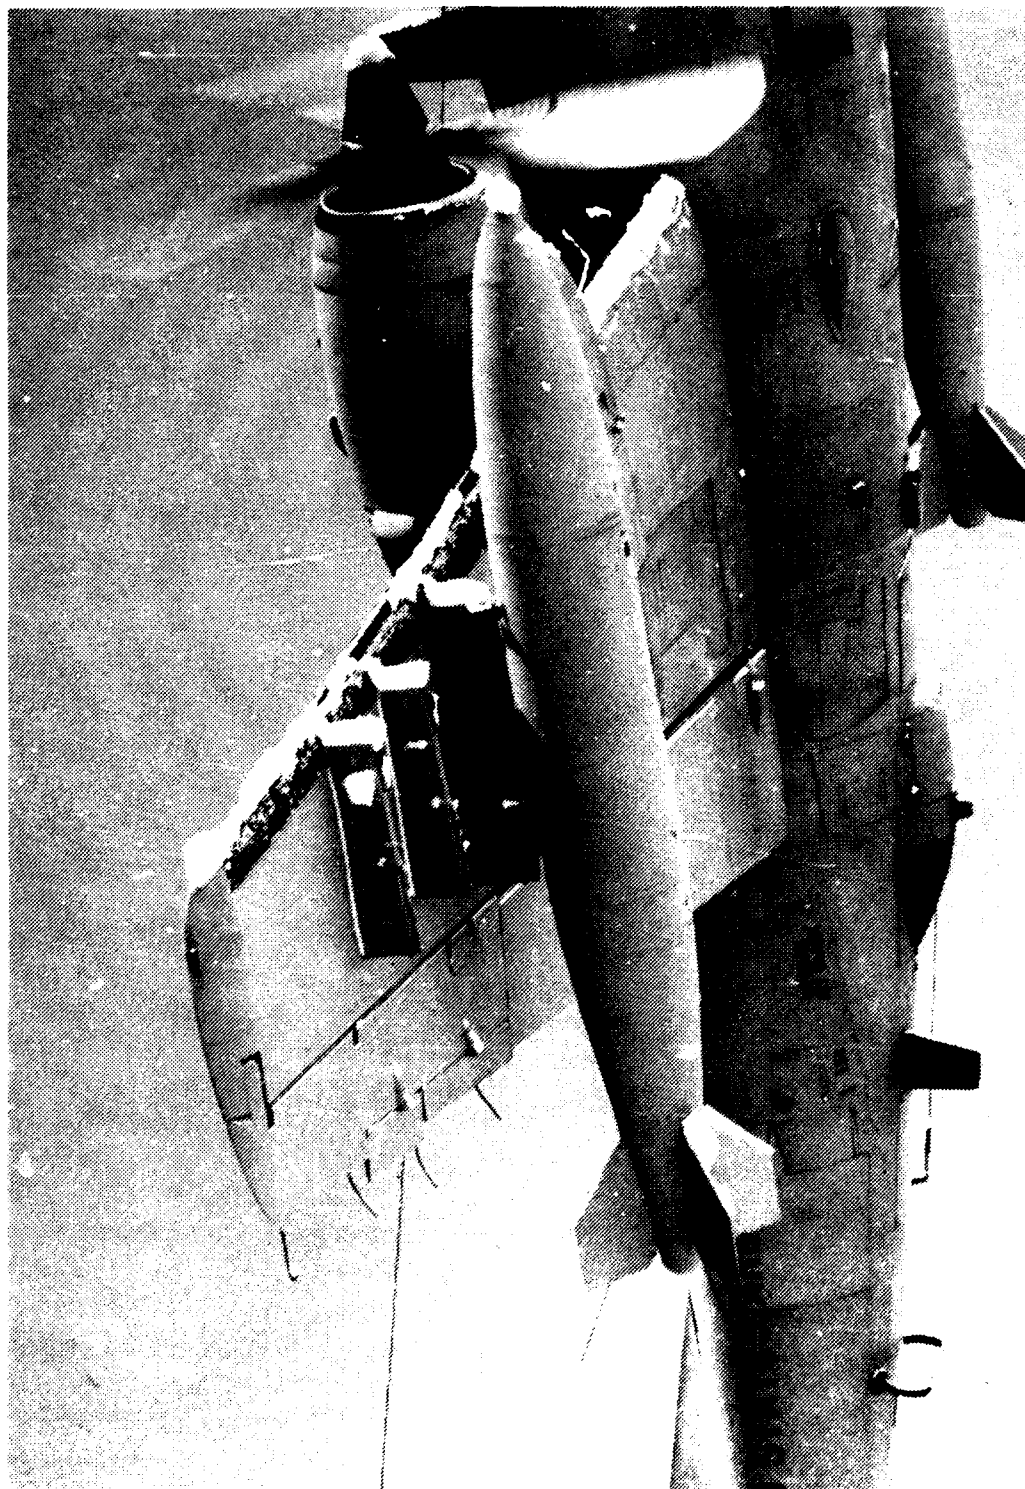
Figure D-7. Wing/Vertical/Horizontal Stabilizer Leading Edge Ice Accretions:  $LWC = 0.17 \text{ gm/m}^3$ ,  
Time in Cloud = 1.0 hr,  $OAT = -12^\circ\text{C}$

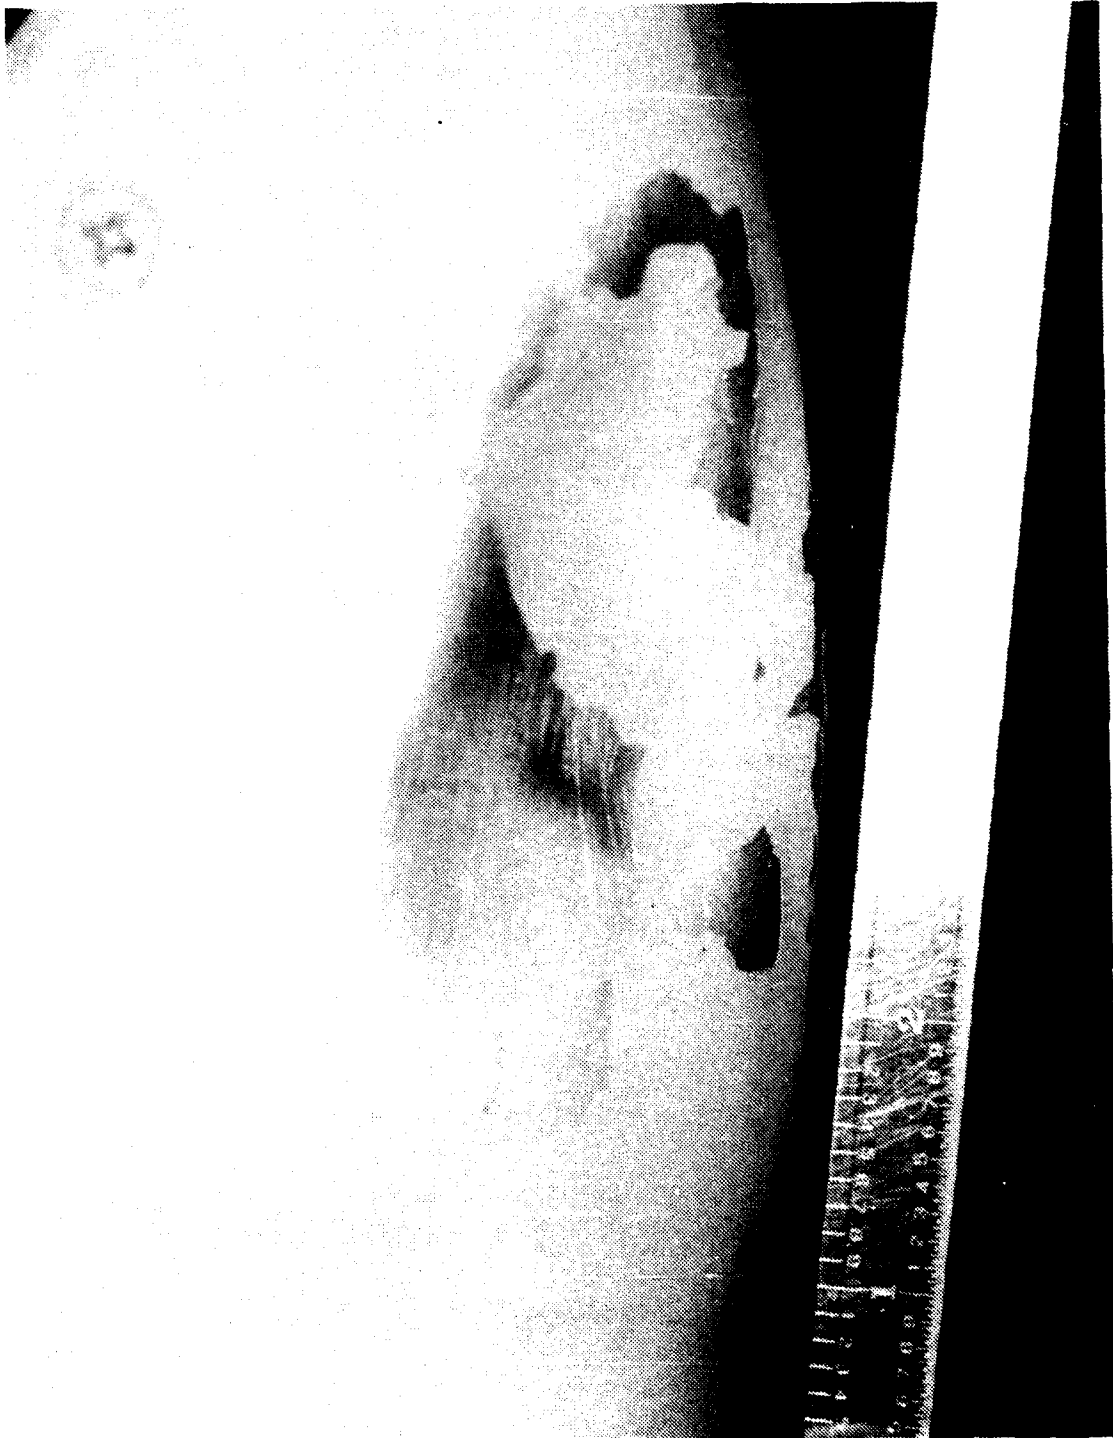
Figure D-9. Ice Damage to Vertical Stabilizer

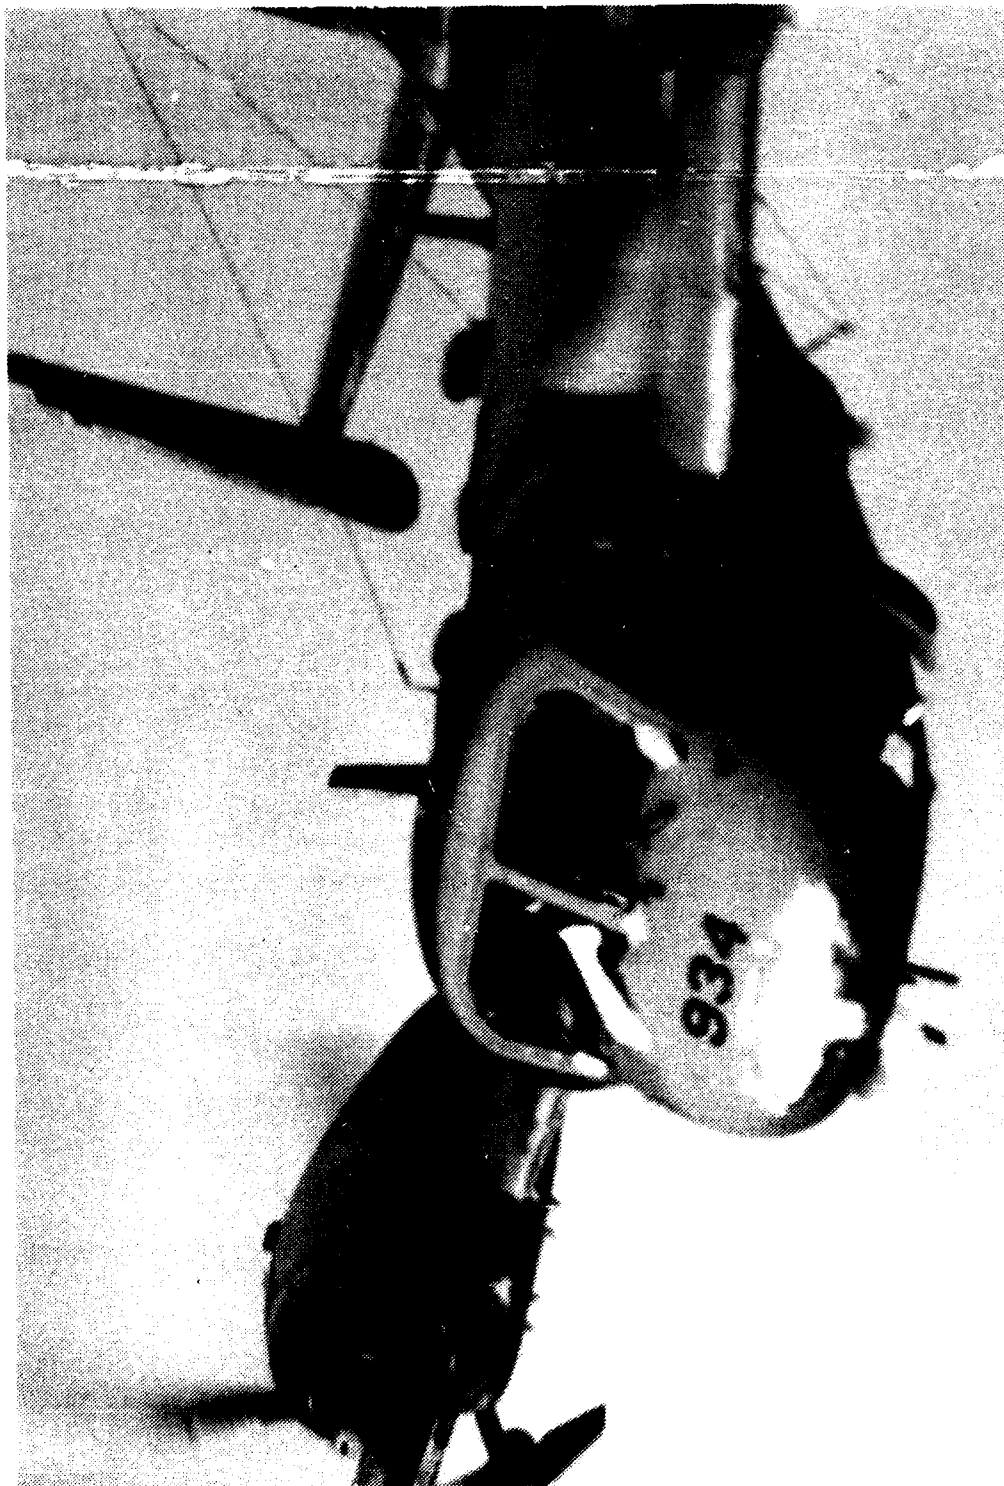
16. During AEFA Project No. 87-25 and during this evaluation there was propeller damage caused by ice departing from the windshield wipers and going through the propellers. Windshield wiper ice accumulation is shown in figure D-10. The ice accretion and shedding characteristics of the windshield wipers are a shortcoming due to the damage caused to the propellers.

b. The ice accretion and shedding characteristics of the windshield wipers due to the damage caused to the propellers (para 16).

Figure D-10. Windshield/Vertical Stabilizer Ice: LWC =  $0.6 \text{ gm/m}^3$ , Time in Cloud =  $0.9 \text{ hr}$ ,  
OAT =  $-8.0^\circ\text{C}$

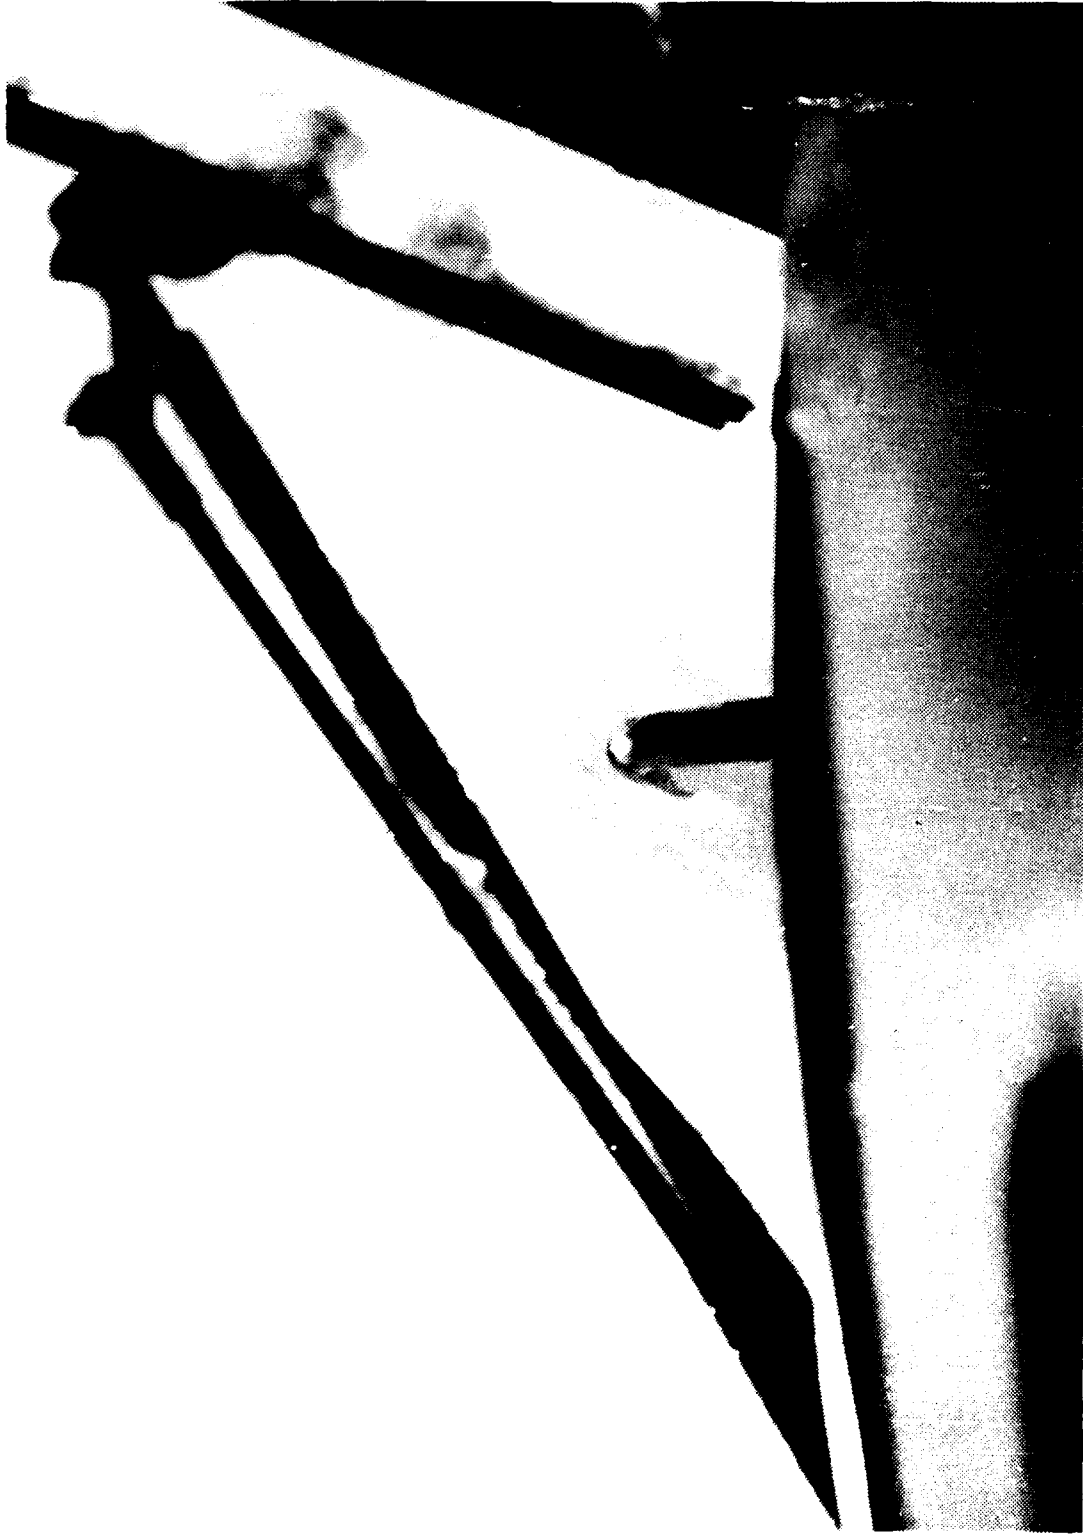
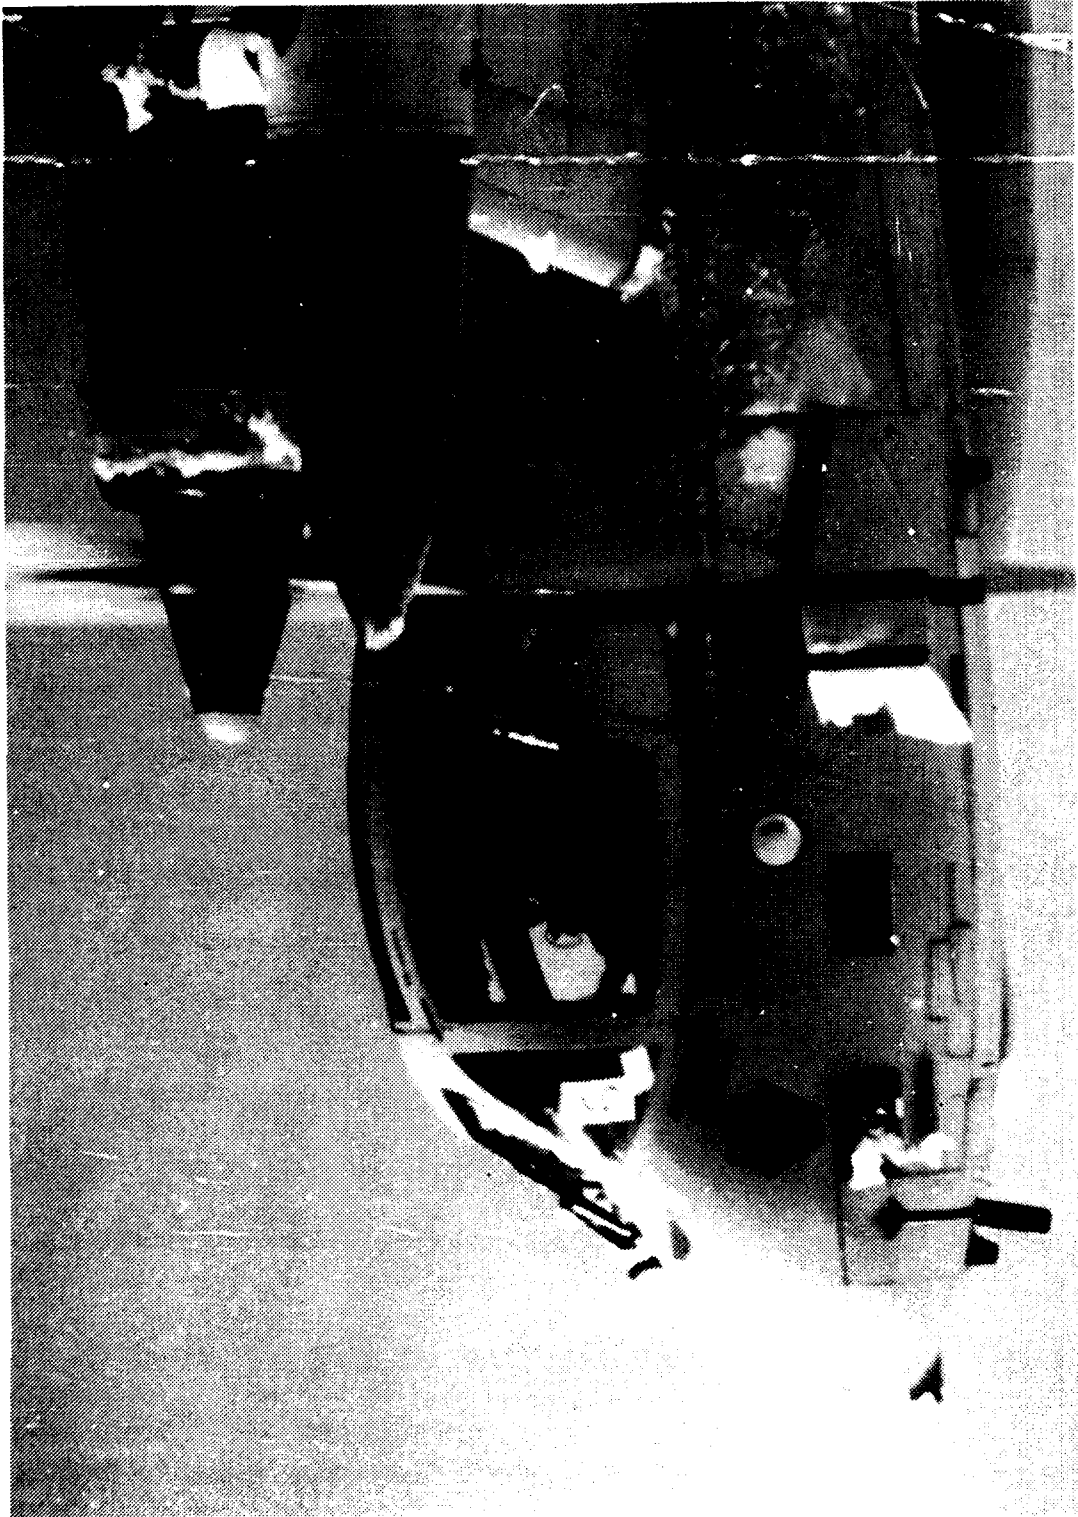
23. During this evaluation in light and moderate icing conditions, ice accretion started on the vertical base of the pitot tube and built forward and up around the pitot tube (figs. D-11 and D-12), never touching the horizontal portion of the pitot tube itself. Airspeed indications were disrupted (the airspeed reading was from 50 to 90 KIAS), after the ice accreted to within one-half inch of the leading edge of the pitot tube opening. The pitot heating element was checked in accordance with maintenance procedures and was verified to be working as required. The aircraft manufacturer has also verified that the pitot heating element was producing specification heat output. The ice accretion characteristics of the pitot tube which result in erroneous airspeed indications are a deficiency.

Figure D-11. Ice on Pitot Tube: LWC = 0.6 g/m<sup>3</sup>, Time in Cloud = 0.9 hr, OAT = -8.0°C

Figure D-12. Ice on Pitot Tube: LWC =  $0.6 \text{ g/m}^3$ , Time in Cloud = 0.9 hr, OAT =  $-8.0^\circ\text{C}$
